Manhole Inspection Summary

Manhole # S45WW_024MH

Insp Date: **3/28/07 9:13 AM**

Location Address: **1900 29TH ST**

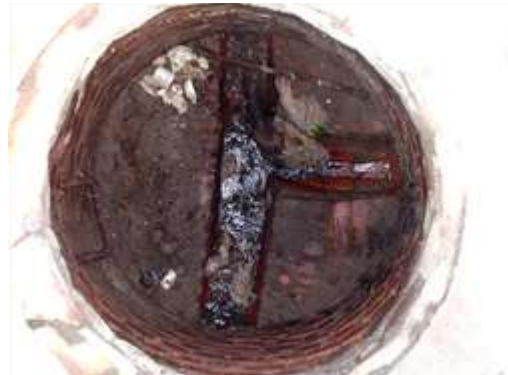
Top View

Missing: **1**

☒ **Corroded**

☒ **Evidence Of Surcharge**

Corroded and missing steps. Evidence of surcharge - Bench debris. Channel debris.

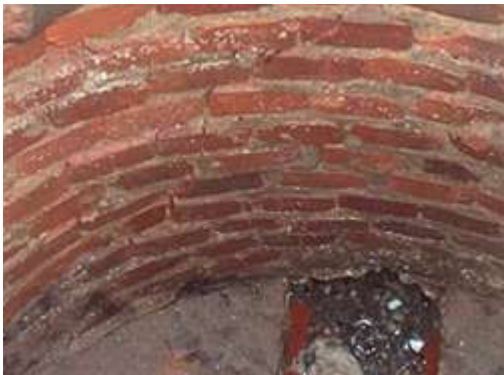
Defect

Condition: ☐ Sound ☒ **Cracked** ☐ Root Intrusion ☐ Loose Brick ☐ Deteriorated

Infiltration: ☐ None ☐ Joint ☒ **Cracks** ☐ Mortar ☐ Roots ☒ **Wall**

Barrel cracks and infiltration.

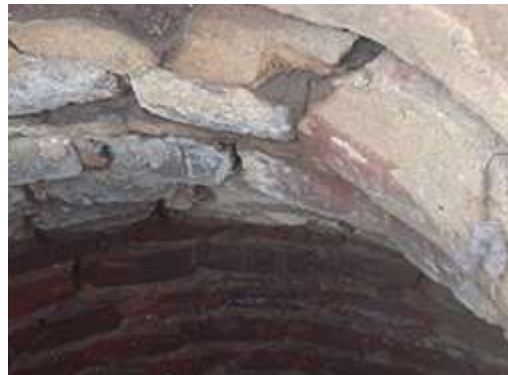
Defect

☒ **Leaks**

Condition: ☐ Sound ☐ Cracked ☐ Root Intrusion ☐ Loose Brick ☒ **Deteriorated**

Infiltration: ☐ None ☒ **Joint** ☐ Cracks ☐ Mortar ☐ Roots ☒ **Wall**

Frame leaks. Frame offset. Adjustment deterioration and infiltration. Corbel infiltration.

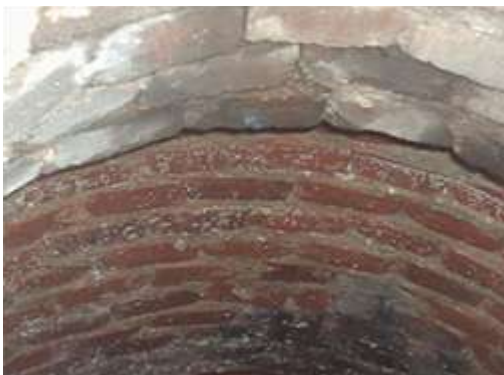
Defect

Infiltration: ☐ None ☐ Joint ☐ Cracks ☒ **Mortar** ☐ Roots ☒ **Wall**

Corbel and Barrel infiltration.

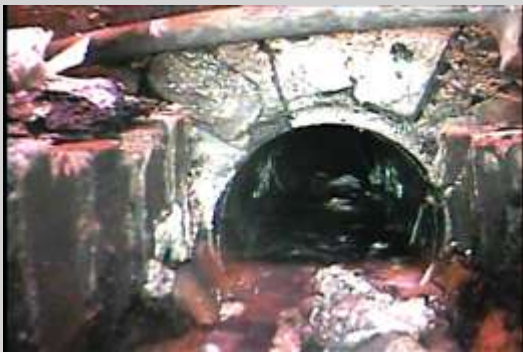
8 in. Circular Gravity Sewer Pipe Out @ 12 O'Clock

Deposits: ☐ None ☐ Mud ☐ Sludge ☒ **Debris** ☒ **Grease**

Silt Depth: **1** (in.) Deposits Extent: **Light**

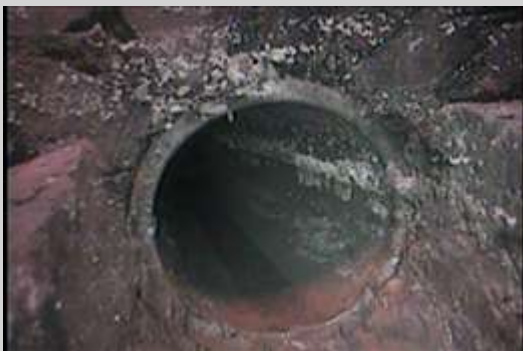
8 in. Circular Gravity Sewer Pipe In @ 3 O'Clock

Deposits: ☐ None ☐ Mud ☐ Sludge ☐ **Debris** ☒ **Grease**

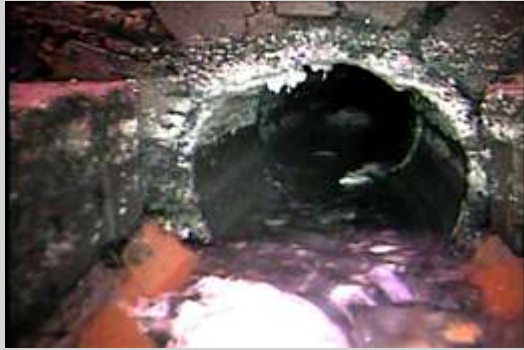
Pipe In @ 7 O'Clock

Deposits: ☐ None ☐ Mud ☐ Sludge ☒ **Debris** ☒ **Grease**

Silt Depth: **1** (in.)
